## **Excessive metal release due to loosening and fretting of sintered particles on porous-coated hip prostheses. Report of two cases**

## Excessive Metal Release due to Loosening and Fretting of Sintered Particles on Porous-Coated Hip Prostheses

REPORT OF TWO CASES\*

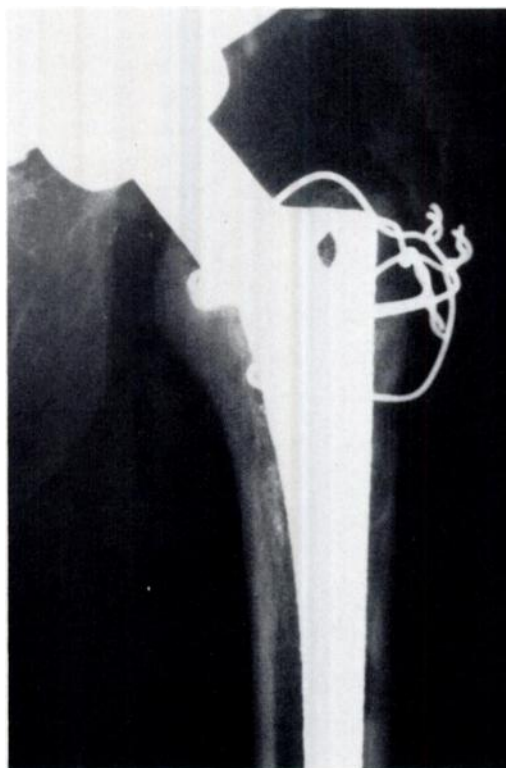
FIG. 1

Fig. 1: Case 1. Four months postoperatively, the radiograph shows subsidence of the femoral component and loosening of metal particles.  
Fig. 2: Case 1. Photograph of the removed prosthesis, with a portion of the capsule blackened by metal debris.

The patient's immediate postoperative course was uneventful. She was kept continuously on partial weight-bearing using axillary crutches. However, despite protected weight-bearing, she began to have progressive pain, and subsequent radiographs showed subsidence of the femoral component and absence of the bone hypertrophy and sclerosis that suggest the

presence of bone ingrowth (Fig. 1). In addition, loose particles from the porous surface were evident proximally, both medial and lateral to the stem.

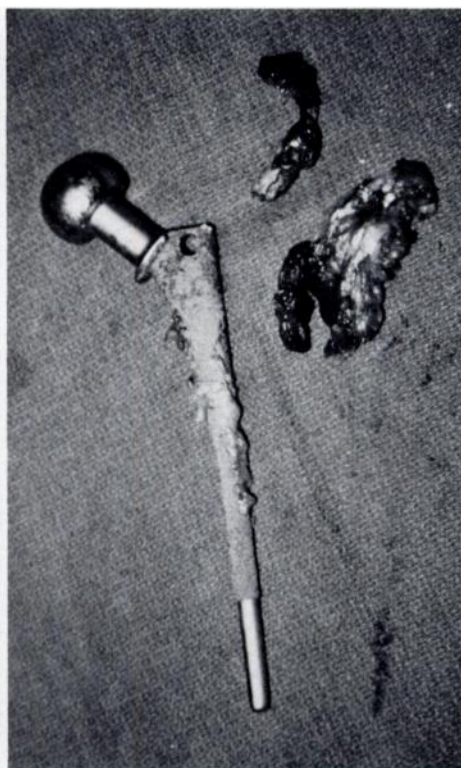
FIG. 2

Because of the patient's deteriorating course, four months after the third procedure a revision operation was performed. When the capsule of the hip was incised, exuberant black-stained tissue was encountered on the inner surface of the capsule, and the entire capsule was seen to be stained with metal debris (Fig. 2). When the femoral component was examined, it was noted to be freely movable within the femoral canal and was easily removed. Many of the sintered particles had been worn off the proximal part of the lateral surface of the stem. The femoral canal appeared darkly stained with metal debris throughout its proximal portion. The femoral medullary canal was thoroughly reamed with high-speed instruments, and a cemented femoral component was inserted. The acetabular component was firmly fixed and was left intact.

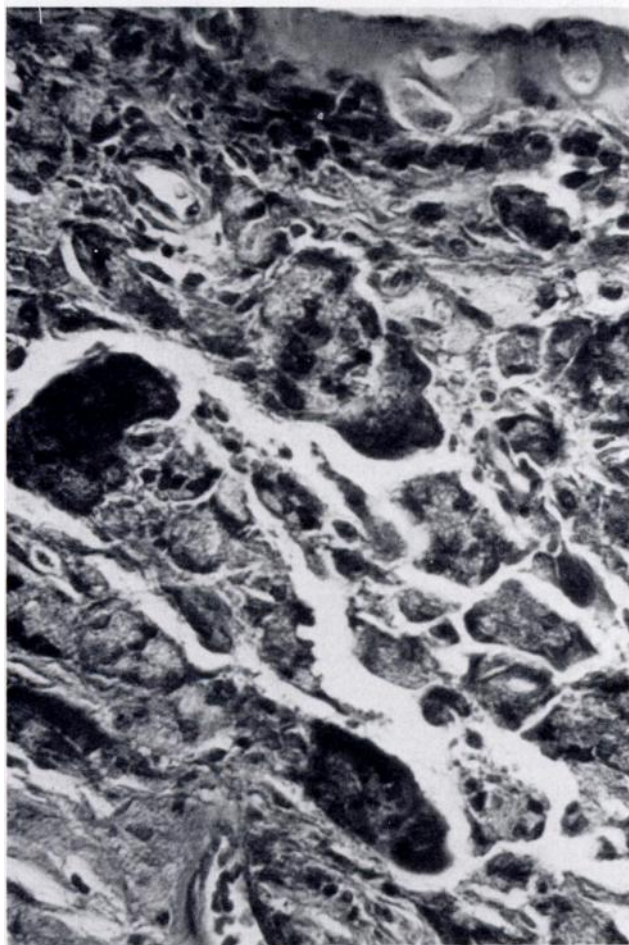
FIG. 3

Case 1. Photomicrograph of the capsule and synovial membrane, illustrating an aggressive inflammatory reaction with metal debris and foreign-body-type giant cells (hematoxylin and eosin,  $\times 100$ ).

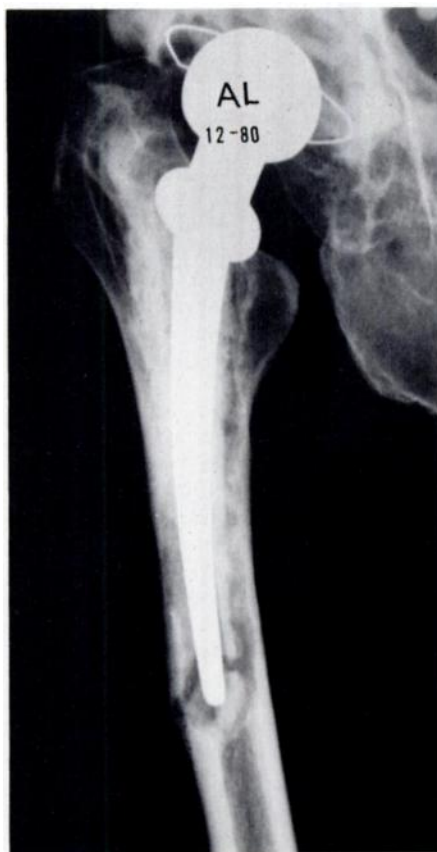
FIG. 4

**CASE 2.** In a sixty-year-old man who had had a bilateral cemented total hip arthroplasty, symptomatic loosening of both components in the right hip developed four years after surgery (Fig. 4). The hip was revised using a cobalt-chromium-alloy porous-coated femoral component (with the same type of sintered coating as in Case 1) of the Mueller design in combination with a cemented acetabular component (Fig. 5). There was a tight fit of the stem within the intramedullary canal, and there was no evidence of loose metallic particles on the postoperative radiograph.

Fig. 4: Preoperative radiograph of the failed cemented femoral implant.

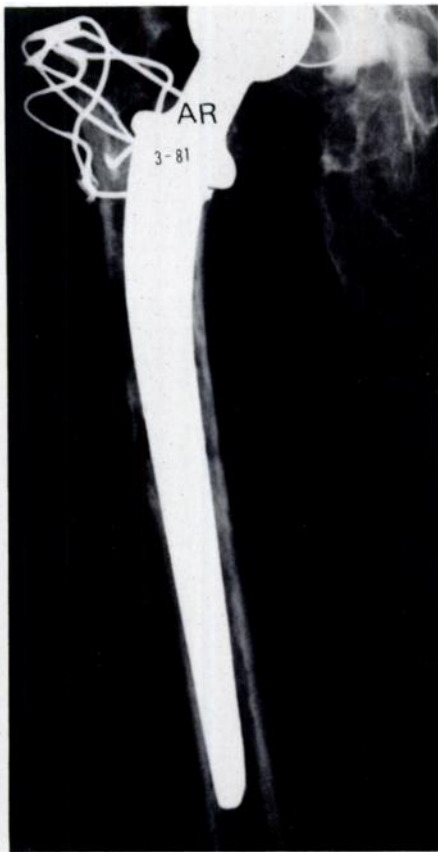
FIG. 5

Fig. 5: Radiograph made immediately after revision using a porous-coated stem. There are no signs of metal-particle loosening.

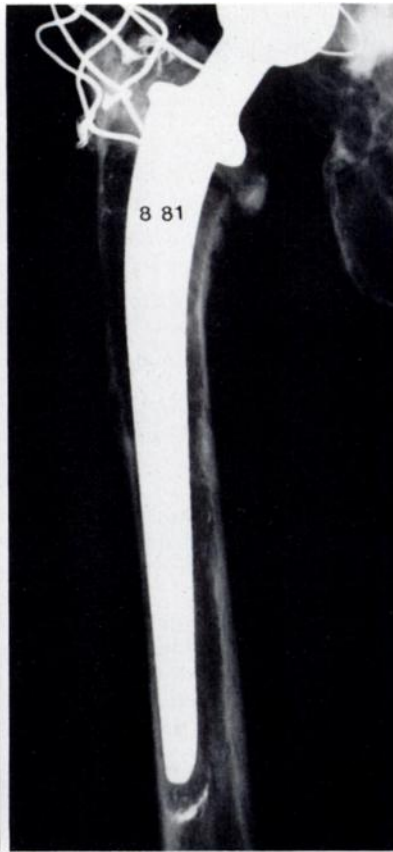
FIG. 6

Over the next five months, the patient began to have increasing pain, even though he had always walked with protected weight-bearing and had pursued a sedentary lifestyle. Radiographs at that time showed subsidence of the femoral component and loose sintered particles along the lateral surface of the distal part of the stem (Fig. 6). Because of the patient's deteriorating course, revision was performed without further delay. At operation, the capsule was not noticeably stained with metal debris, but the femoral component was loose and was easily removed. Slightly stained granulation tissue was removed from within the intramedullary canal in the region where the radiographs showed accumulation of bone particles. A cemented stem was inserted and the acetabular component was left intact. At the time of writing, one year after revision, the patient's course had been uneventful.

Fig. 6: Five months postoperatively, the femoral component has subsided and loose particles have collected near the tip of the stem.

In view of the findings in these patients, it is recommended that when any patient has a painful non-cemented prosthesis and radiographic evidence of motion at the bone-metal interface, the hip should be revised as soon as possible. This would minimize the risk of malignant degeneration and the poorly defined effects of metal-ion exchange.
